NASA Contractor Report 3816

Advanced Composite Vertical Fin  
for L-1011 Aircraft

*Design, Manufacture, and Test  
(Executive Summary)*

A. C. Jackson  
*Lockheed-California Company  
Burbank, California*

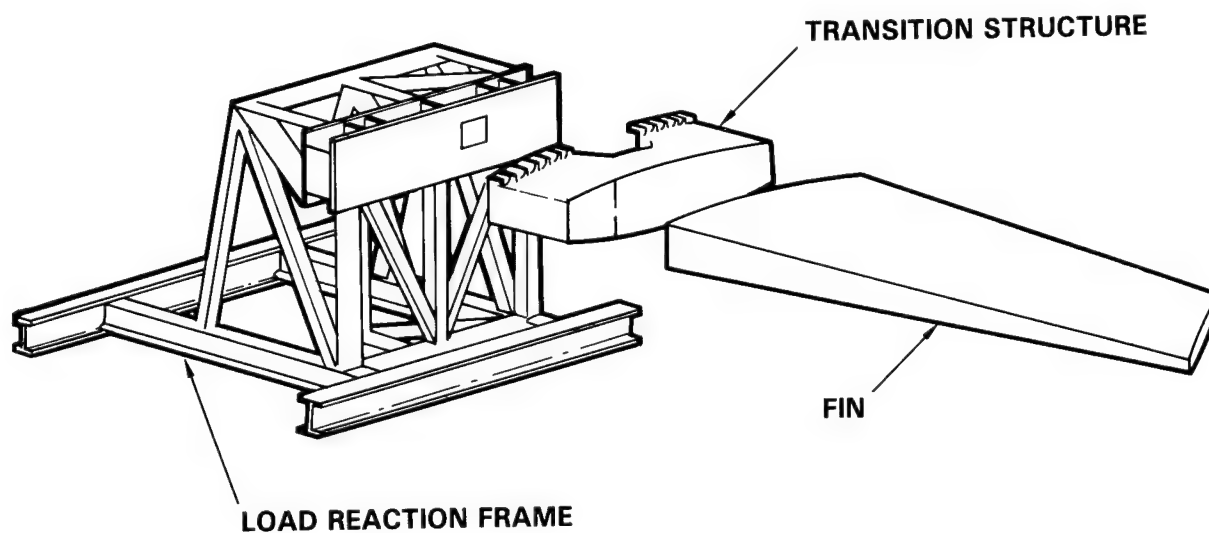
Figure 27. - Test installation of fin in load reaction frame.

The fin and transition structure were attached to the load reaction frame in a horizontal attitude as shown in figure 27.

Externally applied side loads were introduced to the fin along the length of the front and rear spars from jack-trains which were mounted on the floor. Fore- and aft-direction external loads were applied to the fin through the rudder actuator retention brackets.

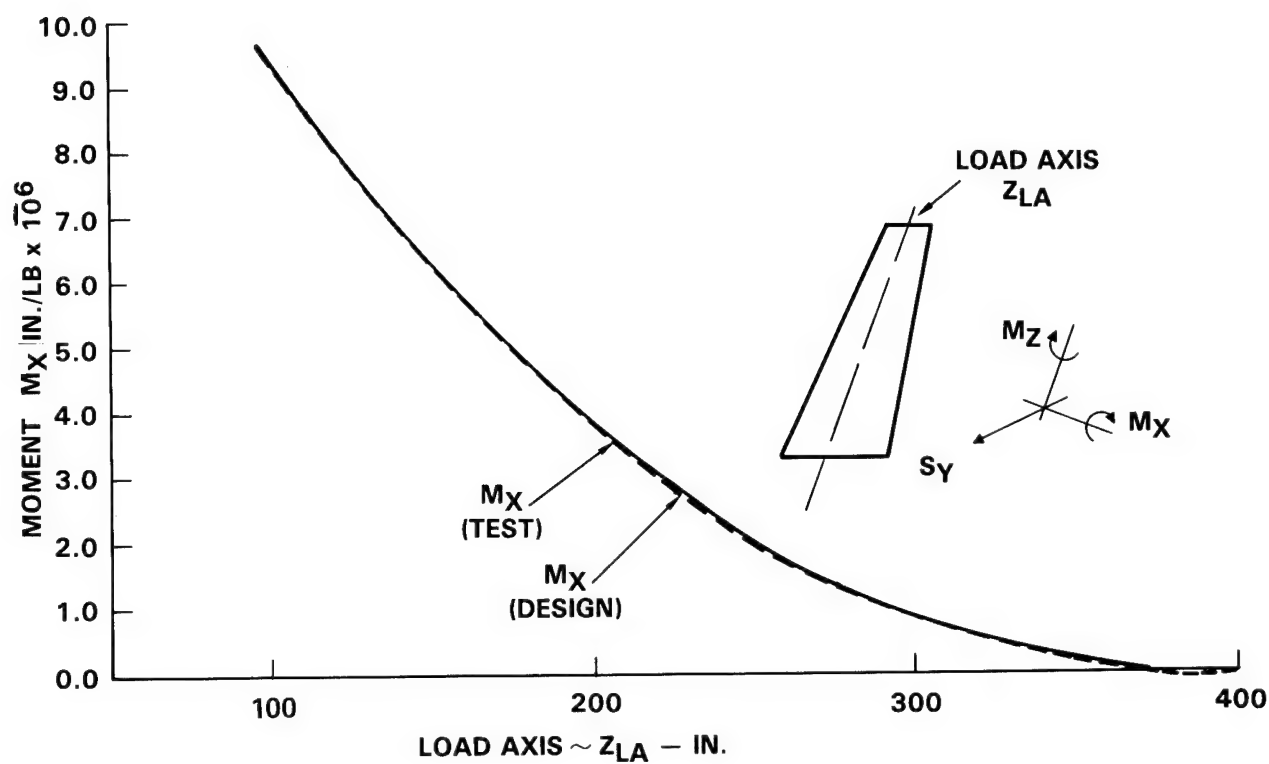
Figure 28. - Test bending moment compared with design bending moment.

The ground test article (GTA) was tested with static loads simulating a high bending dynamic lateral gust condition. This condition was critical for the front spar and covers and adequately loaded the whole structure. A comparison of the design and test bending moments is shown in figure 28. A factor of 1.06 was applied to the loading to account for environmental effects as the tests were conducted at ambient temperature and moisture levels.
